TMMT has been working with FEKA AUTOMOTIVE as its supplier of mirror covers. The mirror covers are made of Acrylonitrile Butadiene Styrene (ABS) and injection molding process is applied in the phase of production. Manufactured parts are painted in the Plastic Shop and are then oven cured at 80°C for 20 minutes according to standard procedure.

The production process has been interrupted many times over the past months due to a surface defect problem on painted mirror covers.

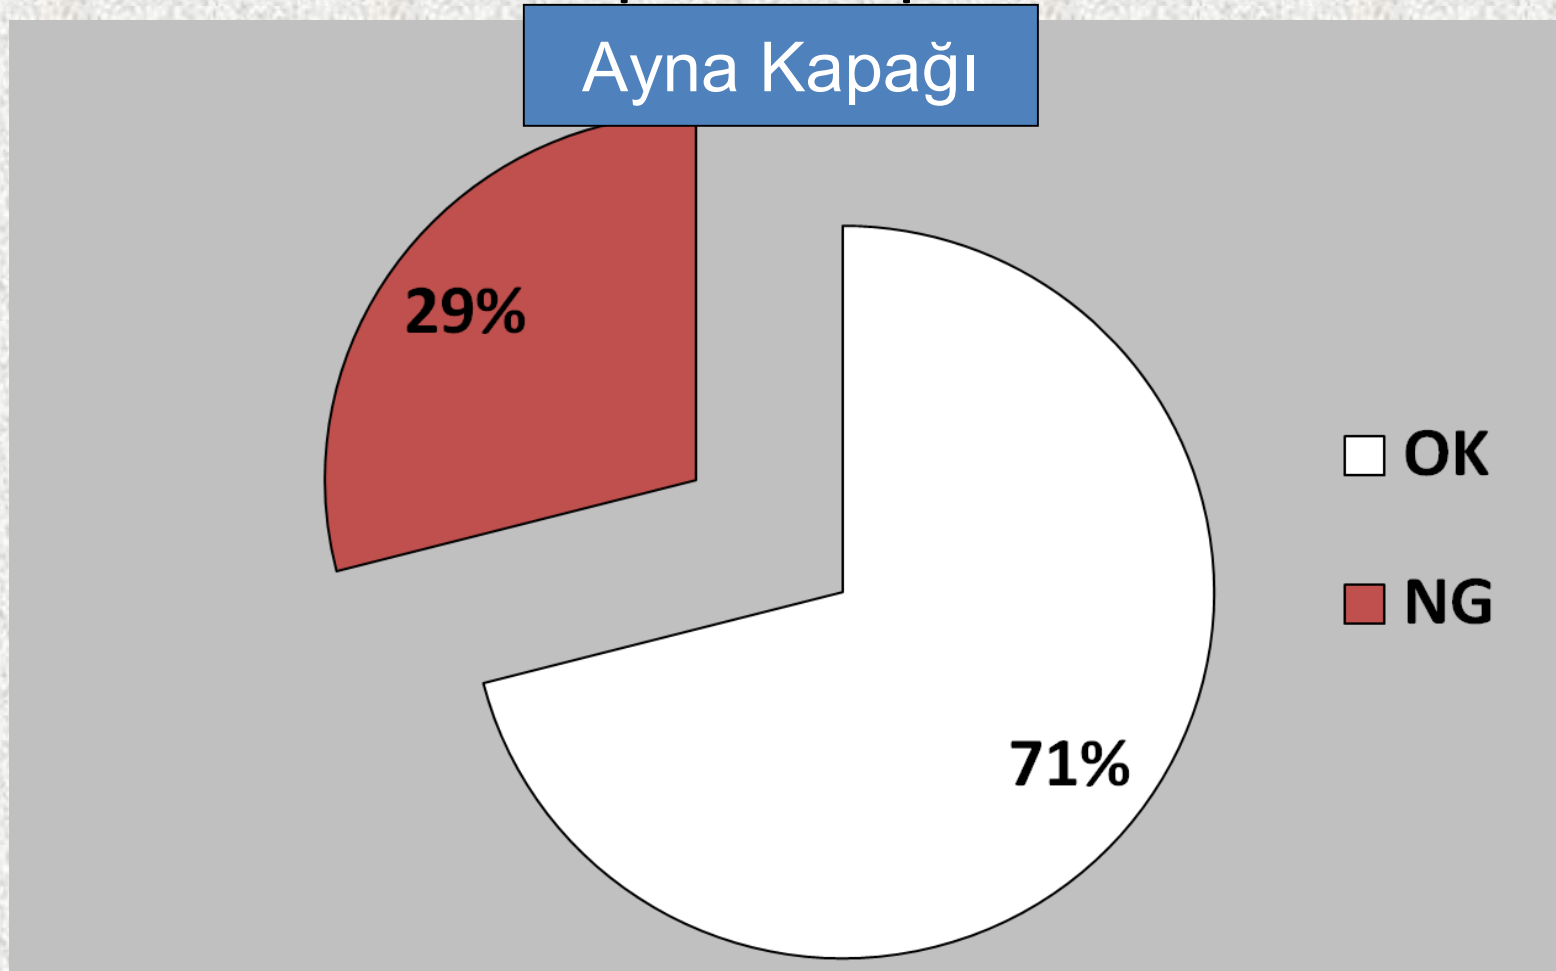
Üretilen ayna kapaklarının 29%'u kalite kontrolden geçemiyor. Ve montaj hattına gönderilemiyor

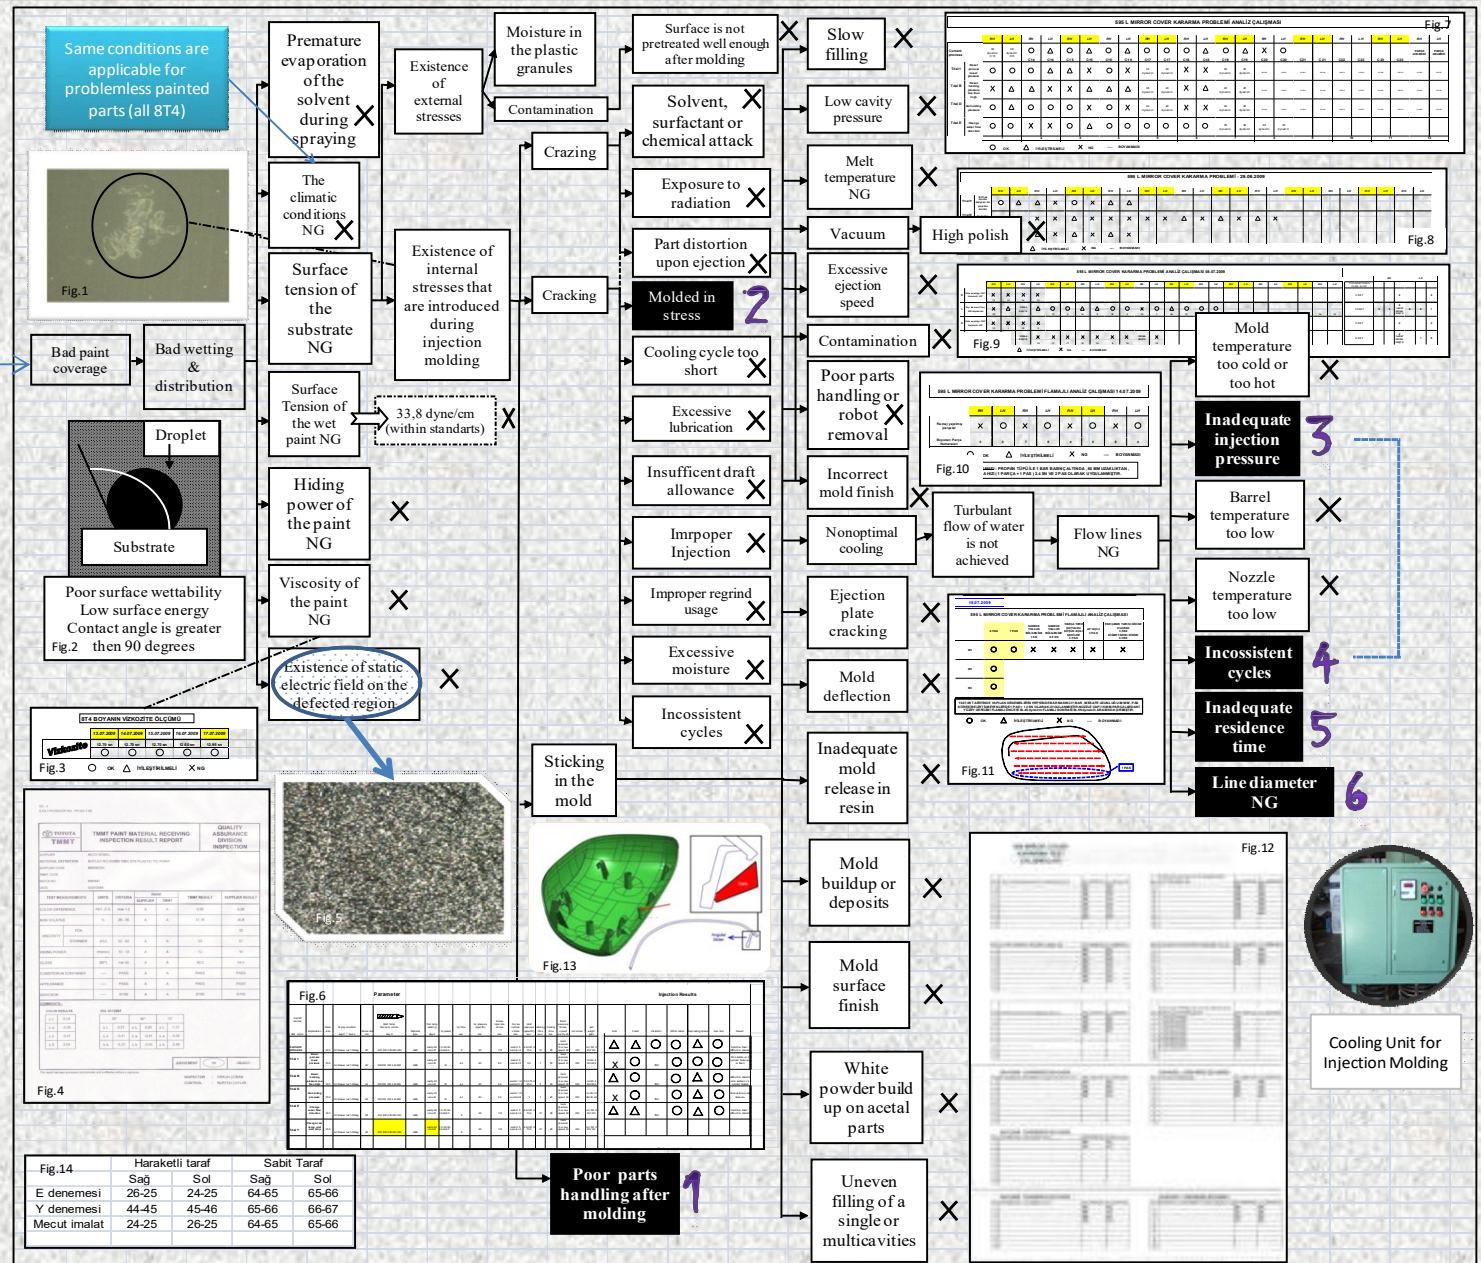
Surface defects on RH mirror covers of 595L model when painted with 8T4

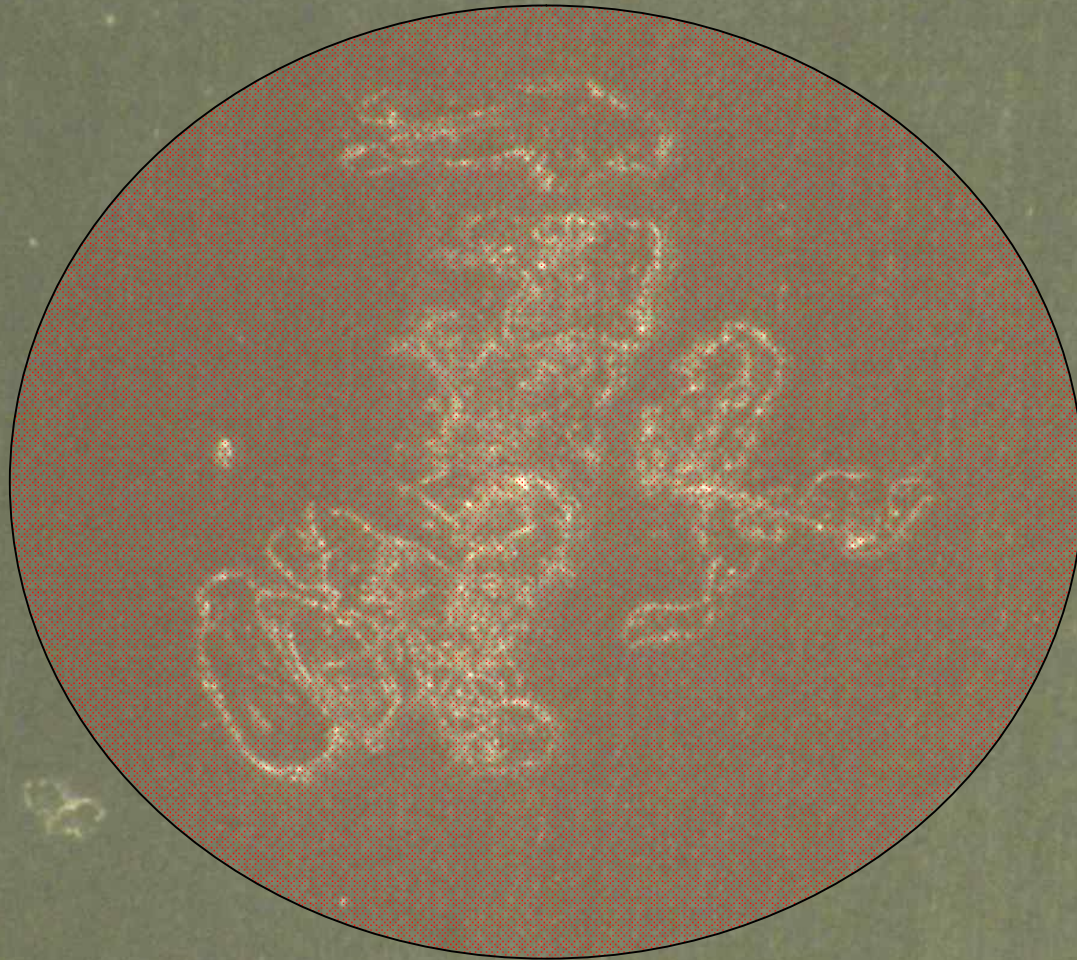
Crazing

R / C	COUNTERMEASURE	Evaluation						BEFORE	AFTER
		Effect	Cost	Quality	Applicability	Overall	Comment		
1	Automate & Standardize excess part removal after molding	△	△	△	X	X	Problem with effective application of processes concerning the supplier	NG	NG
2	Nitrogen Annealing	O	△	O	O	O	Efficient and easy to standardize	NG	OK
	Torching	△	O	△	△	△	Efficient but hard to standardize	38-40 dyne/cm	54-59 dyne/cm
3	Increase Flow Pressure	X	O	△	X	X	Permanent Solution not achieved	NG	NG
4	Change cooling liquid	?	O	?	O	?	Problem with effective application of processes concerning the supplier	?	?
5	Change Flow Line Path	?	X	?	?	?	Make sure the difference in temperature between in and out of water lines is less than 2°C	T _i -T _f >2°C	?
6	Increase Line Diameter	△	X	△	?	?	You need a Reynold's number of 5000 or greater to achieve turbulent flow (optimum cooling).	?	?
