TMMT has been working with FEKA AUTOMOTIVE as its supplier of mirror covers. The mirror covers are made of Acrylonitrile Butadiene Styrene (ABS) and injection molding process is applied in the phase of production. Manufactured parts are painted in the Plastic Shop and are then oven cured at 80°C for 20 minutes according to standard procedure.

The production process has been interrupted many times over the past months due to a surface defect problem on painted mirror covers.

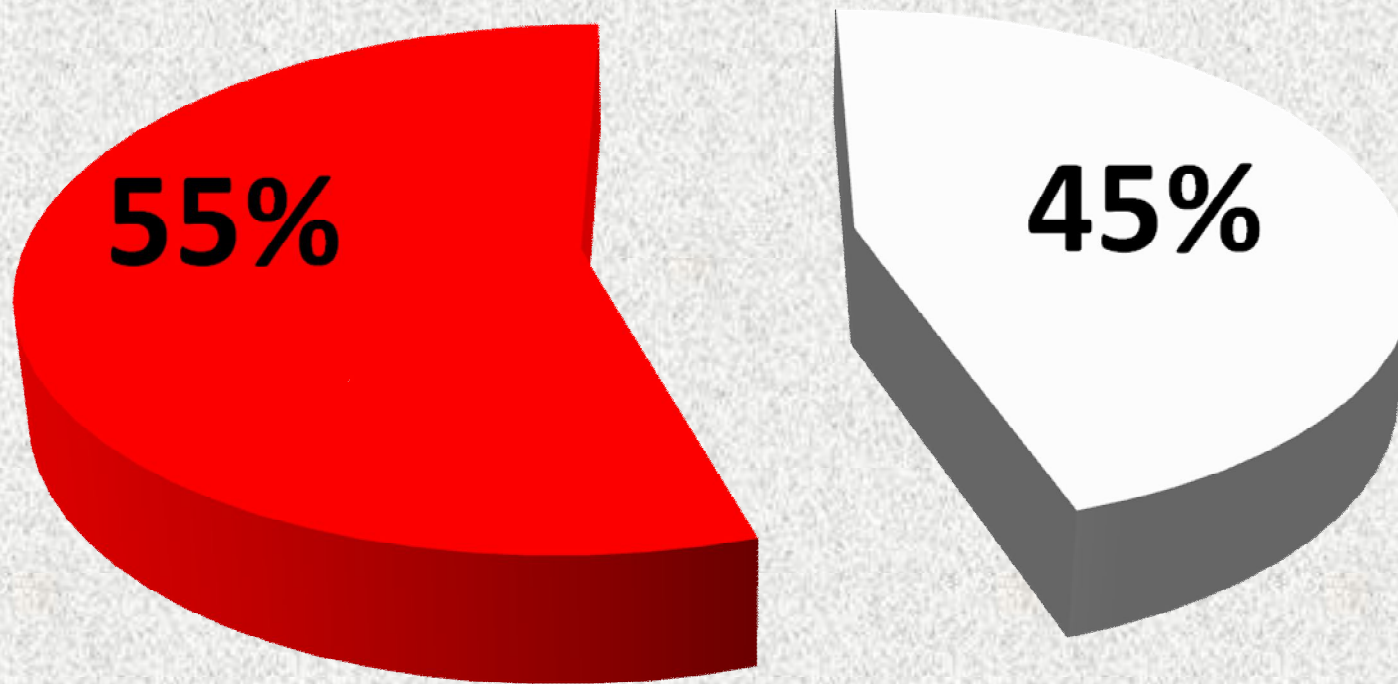
Vardiya Bazlı Problem Dağılımı

İnsan etkisi yok !

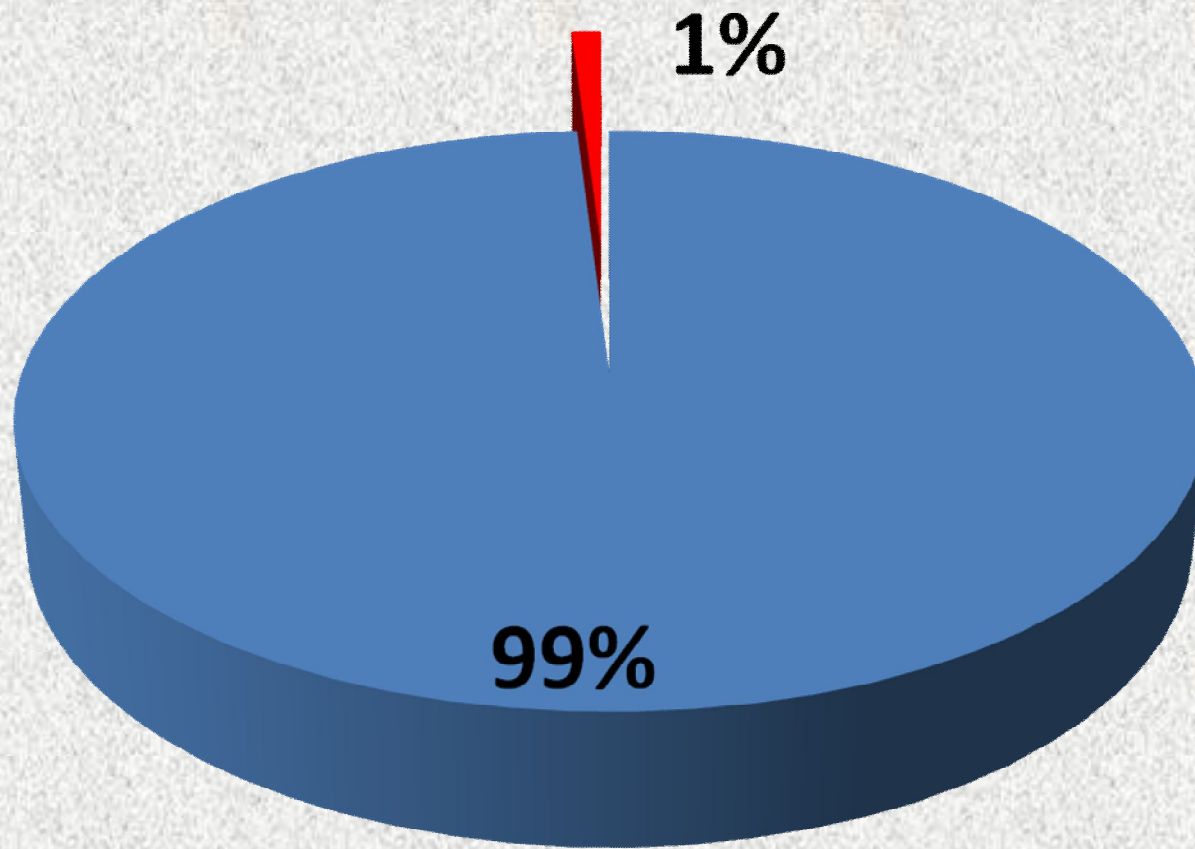
Üretilen Model Bazlı Dağılım

According to data, the surface defect is predominantly observed on one specific model (595 L).

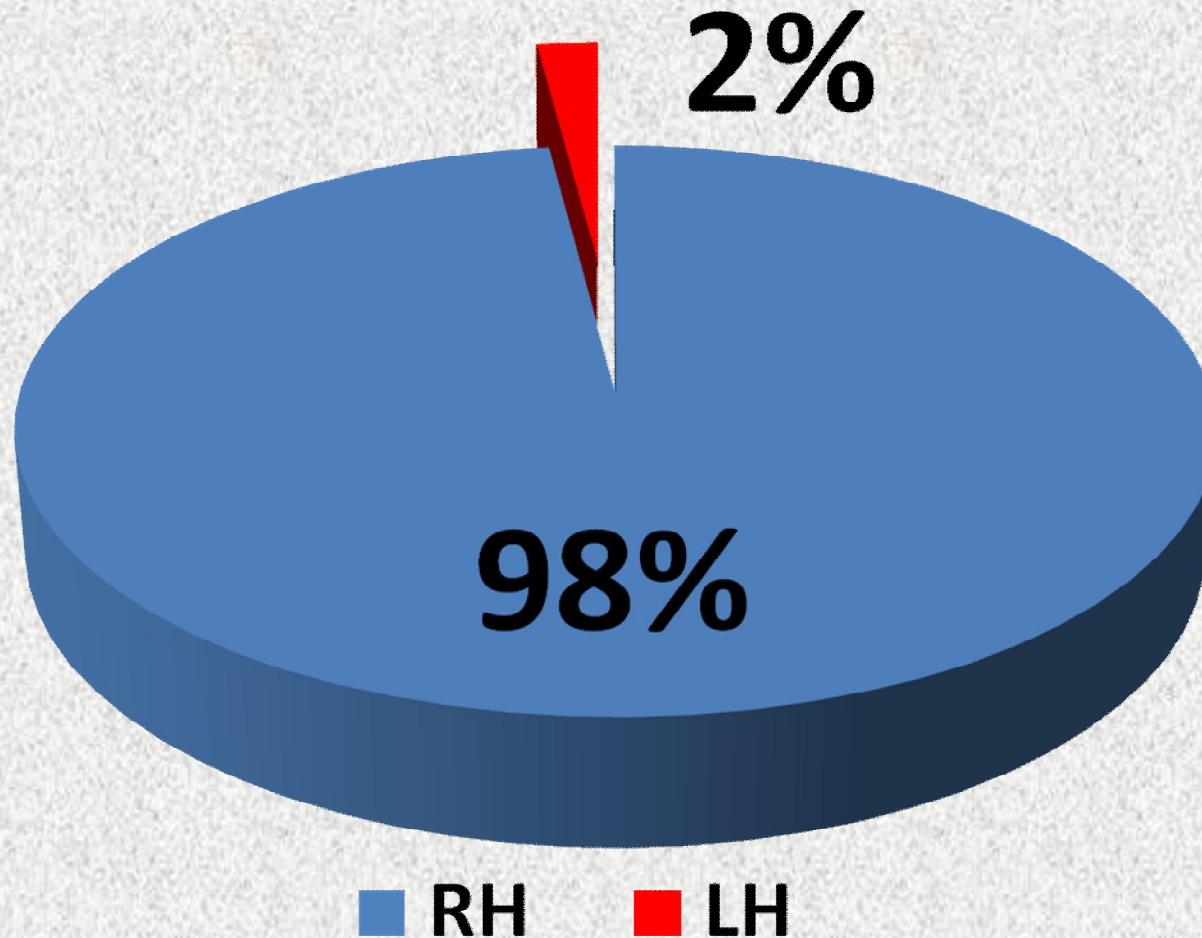
Sol / Sağ Ayna Dağılımı

Defects are mostly encountered on the right mirror covers.

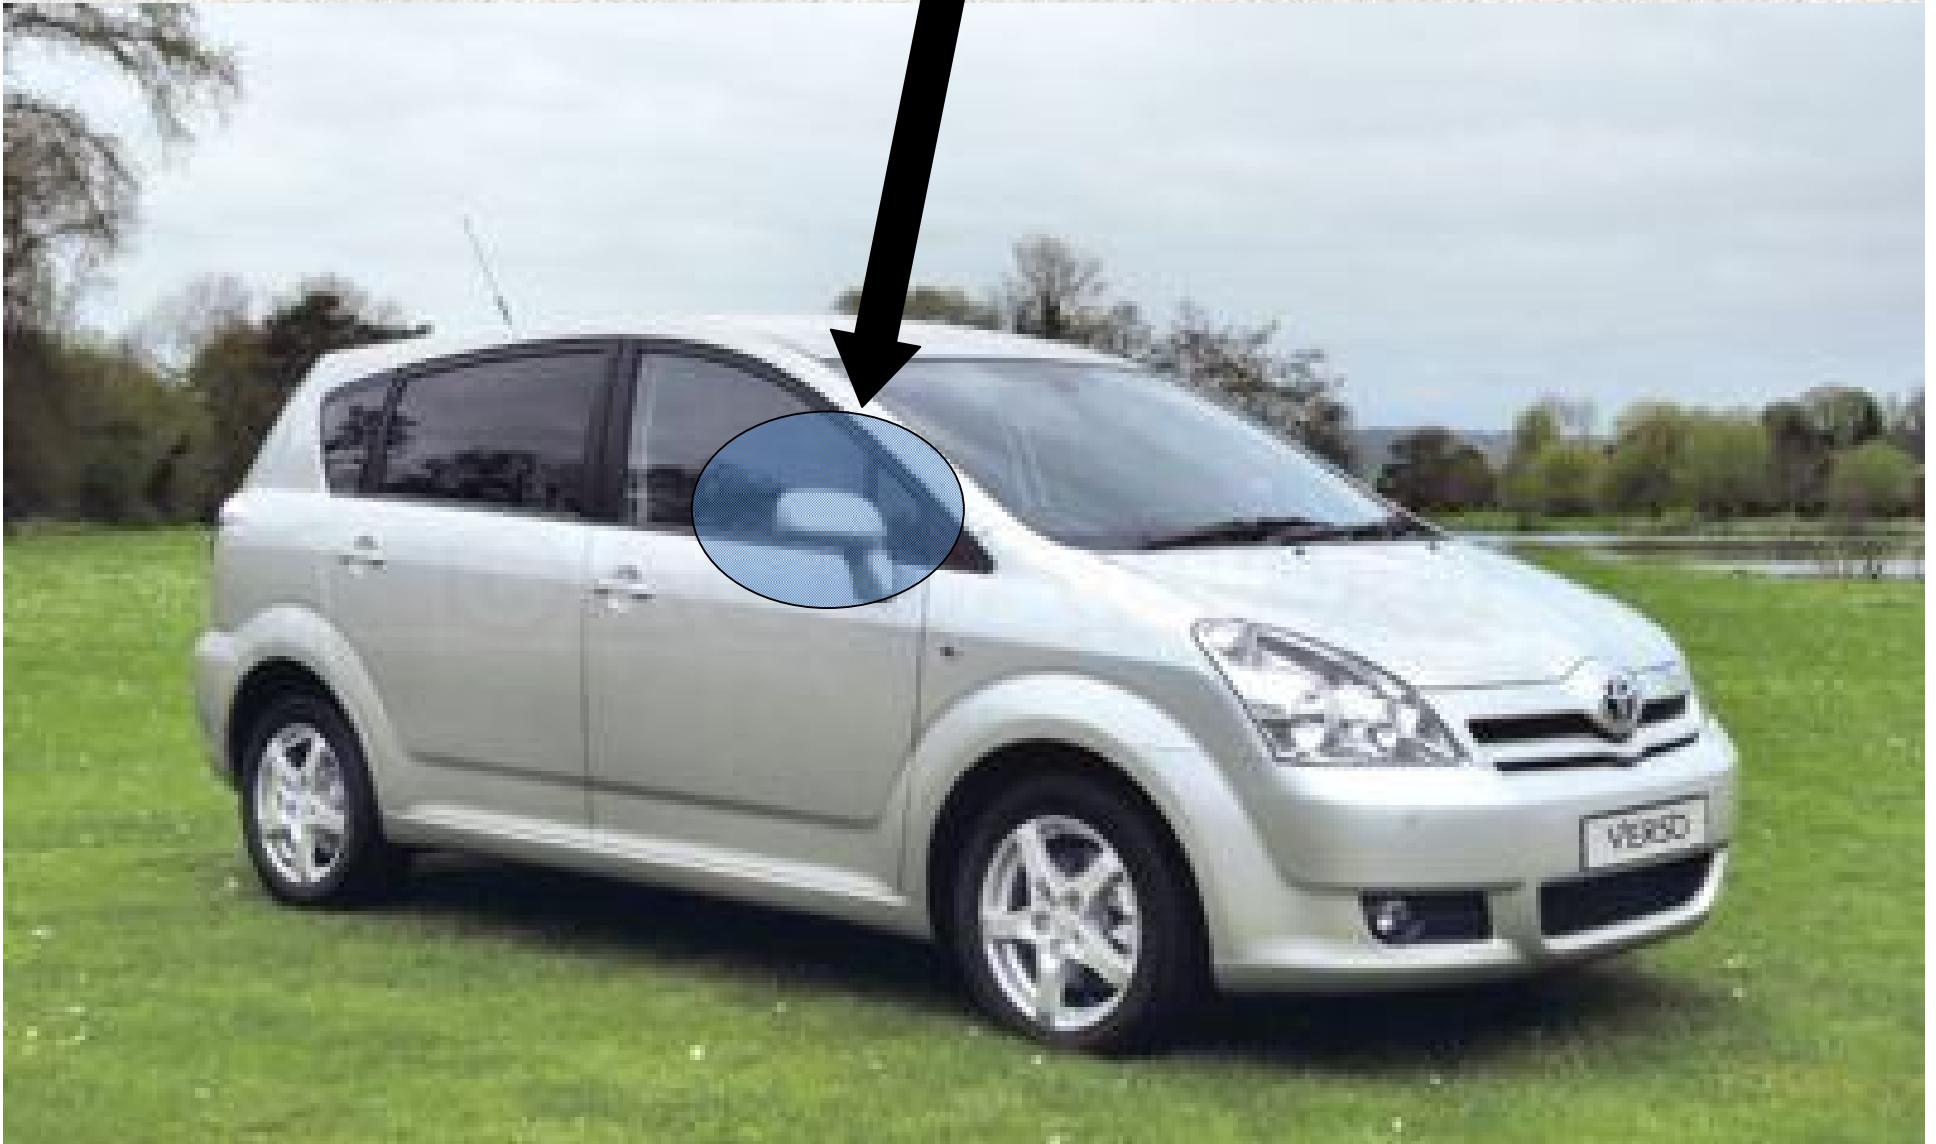
PROBLEMİN ÇIKTIĞI YER

Ayna Yüzeylerinde yer alan “Yüzey hataları” problemi, 595L modellerinde, sağ tarafta ve 8T4 (Metalik Mavi) renkte ortaya çıkmakta
